McDANIEL LAKE DAM

GREENE COUNTY, MISSOURI

MO 20038

PHASE 1 INSPECTION REPORT NATIONAL DAM SAFETY INSPECTION

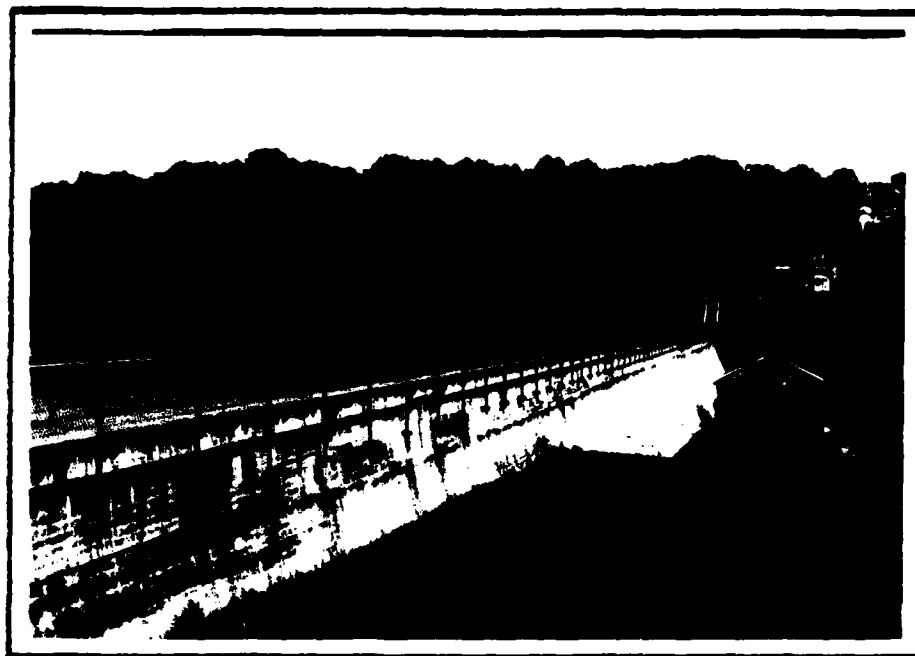
Photograph 1

Downstream slope of dam near right abutment
